THIS IS A GUIDE ON REPAIRING YOUR BEYONWIZ AD055H018 MODEL POWER SUPPLY UNIT

THIS MODEL PSU IS FOUND IN ORIGINAL MODEL DP-S1 UNITS ONLY. I HAVE NAMED THE REPAIR THREAD BY THE PSU MODEL NUMBER.

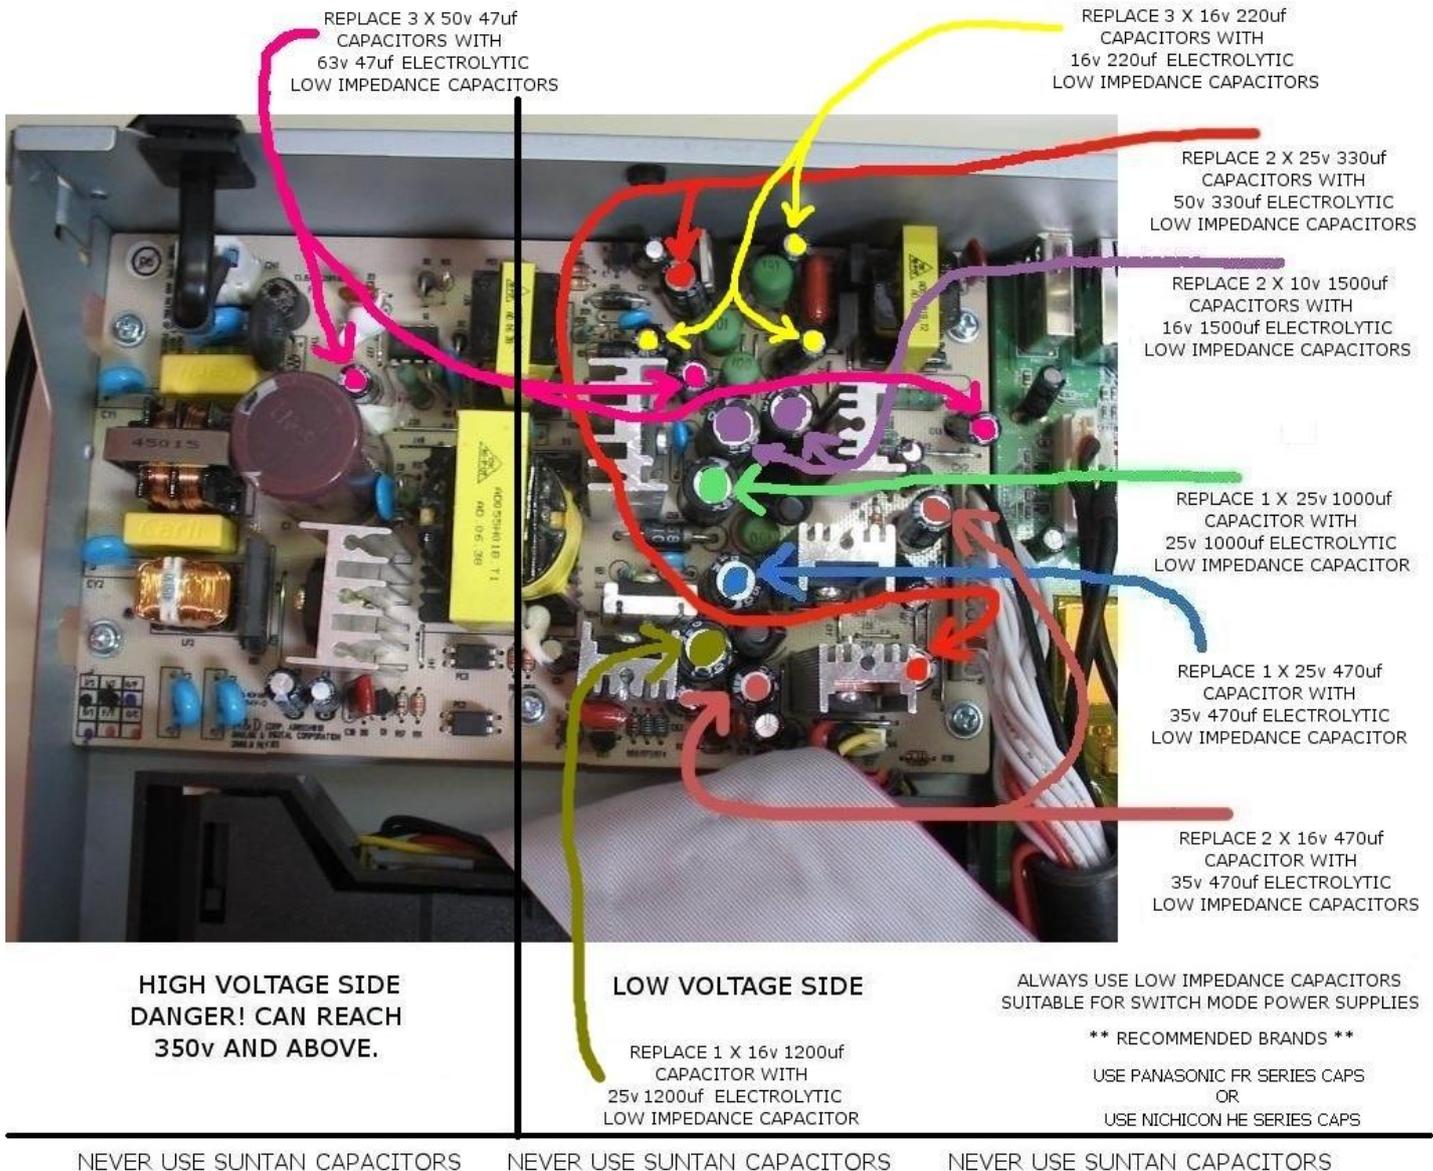
PICTURE 1 below displays the FIFTEEN (15) capacitors that should be replaced for continued longevity of your PSU. There are lots of arrows and colours, so follow them CAREFULLY and refer to PICTURE 4 as well showing the PCB joints on the back of the board further down. The colours match PICTURE 1.

These capacitors relate to and filter the many power rails of the power supply. Sometimes these capacitors are raised up and are swollen/split at the top or bottom, but this is NOT ALWAYS the case, and if yours are not swollen, it definitely DOES NOT mean that your capacitors are therefore ok. Replace them all regardless.

Now it's time to replace the capacitors on the board. You will need to replace 15 capacitors in total. The voltage and specification for each capacitor is detailed in PICTURE 1 above. I have also detailed the PCB PART NUMBERS below as well as providing PANASONIC PART NUMBERS for ordering replacements from Element 14 (Farnell) or RS Components (below).

Below are the PCB PART NUMBERS to replace and also a SUGGESTED REPLACEMENT for each. (All replacements listed below have been specifically selected for their quality, SIZE and suitability)

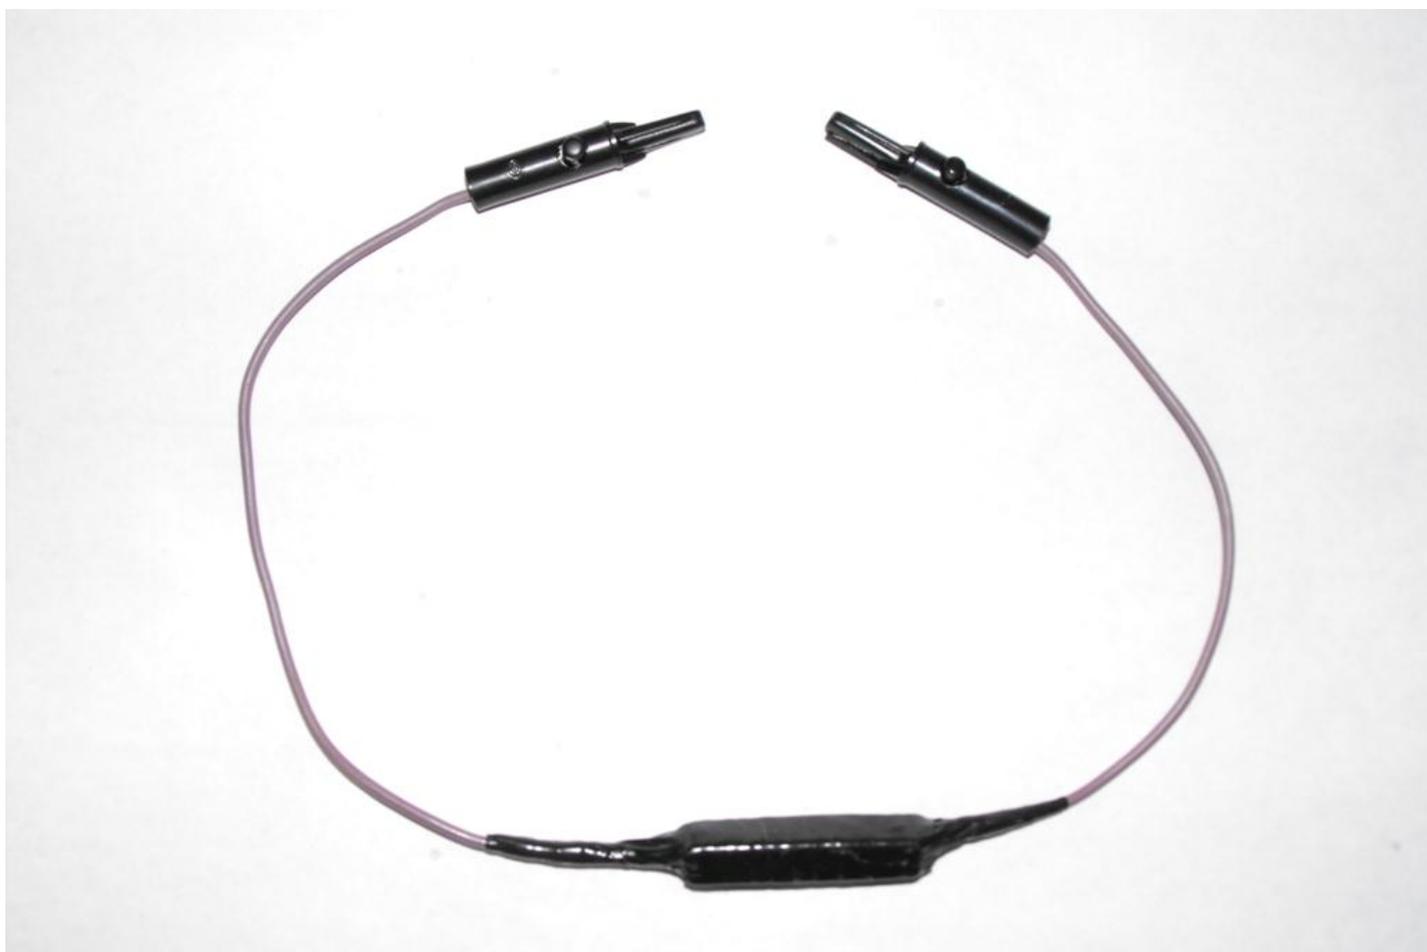
2 x **INSULATED** alligator clips
40cm of 14awg stranded wire
10k ohm, wire-wound, 10 WATT RESISTOR

Solder an alligator clip to both ends of the 40cm wire. Then cut the wire about 18cm along from one end, and solder the resistor in place onto both cut ends. Now wrap the resistor and solder points with at least **THREE** layers of **ELECTRICAL TAPE**. Alternatively, you can use heat shrink tube, at least 2 layers of it, one over the other. **PICTURE 2** below is what it should look like when finished, or similar anyway!

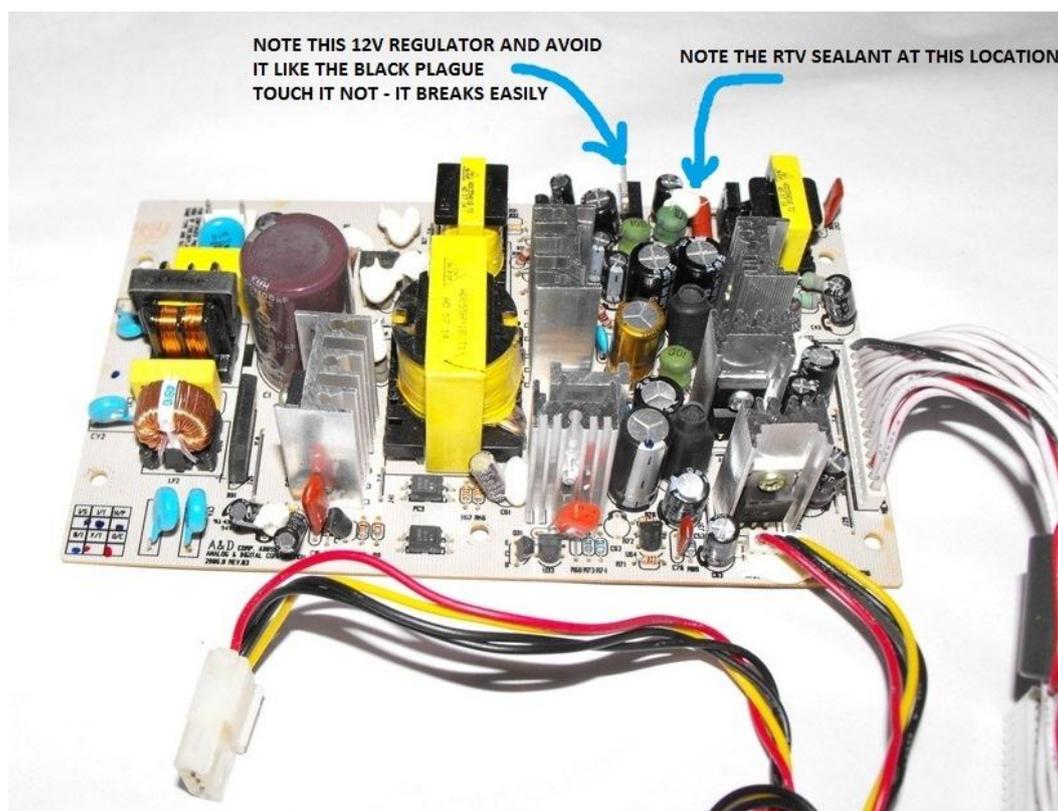
8. Now you can disconnect the DVD power cable and the HDD power cable (not the IDE cable) from the back of the drives, this cable is NOT removable from the PSU. Lift the PSU up carefully by the edges and get ready to repair it! You should now be staring at your power supply. It "should" look something like PICTURE 3 below.

Another point you should note while working on your power supply – PAY CAREFUL ATTENTION TO THE REGULATOR SHOWN IN PICTURE 3 ABOVE. This regulator is notoriously bad. It has no heat sink and usually no RTV sealant on it and the slightest movement of it will almost certainly crack the PCB joints underneath. Over time it has gotten very brittle around that area on the PCB. You will need to replace a 220uf 16v capacitor (C46) right next to that regulator and 2 others close by. C46 almost always has sealant on it.

Be careful removing and replacing C46 and you should be right. Check and resolder the 3 legs of the regulator once you have finished replacing that capacitor and the others around it just to be sure that it hasn't cracked off the board. This is a common problem and if yours is loose or has cracked and lifted up the PCB tracks, then you will need to do remedial repair work on it to fix it, which includes scraping back the green protective coating on the tracks leading away from the regulator and re-solder everything with a thick trail of solder to secure it better and bridge the breaks in the PCB tracks. Not an easy job.

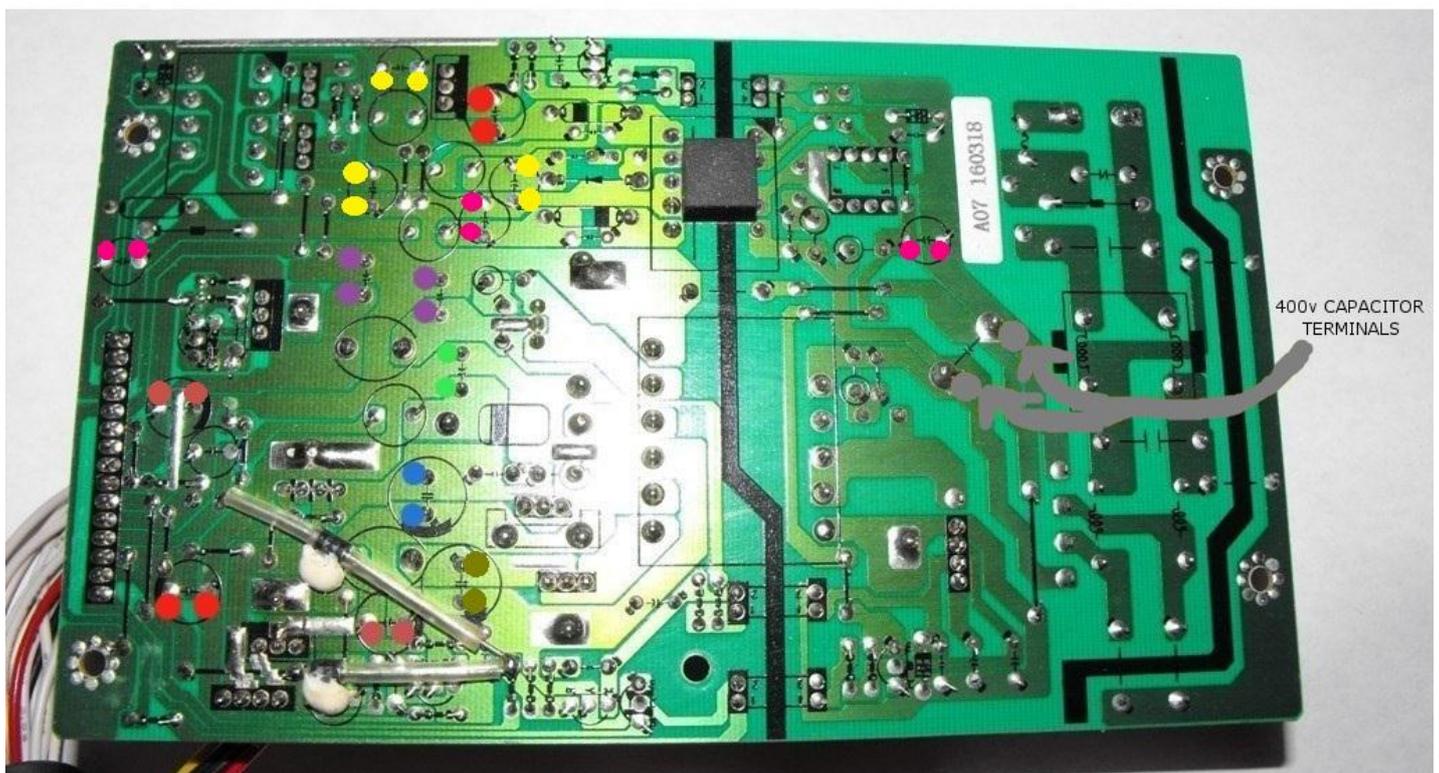
In PICTURE 4, you can see the underside of the PSU board, and as mentioned above I have colour marked the points you will need to unsolder in the same colours as PICTURE 1 above.

470uf CAPACITOR TERMINALS	1500uf CAPACITOR TERMINALS	1000uf CAPACITOR TERMINALS	330uf CAPACITOR TERMINALS	1200uf CAPACITOR TERMINALS	47uf CAPACITOR TERMINALS	220uf CAPACITOR TERMINALS

If you carefully turn your PSU over and look at the solder side of the PCB, you can familiarise yourself with where the points are that you will need to unsolder. Refer to PICTURE 4 below.

Carefully connect the alligator clips to the capacitor terminals/solder points on the PCB (one clip to each exposed terminal, don't short them!). Look at PICTURE 4 below for the location of the BIG 400v capacitor solder points, I have marked them in GREY. Once attached, the resistor will drop the voltage down in around a minute or so, count to 90 slowly and then unclip and you're done. Test using a multimeter if you have one to ensure that the voltage is nil.

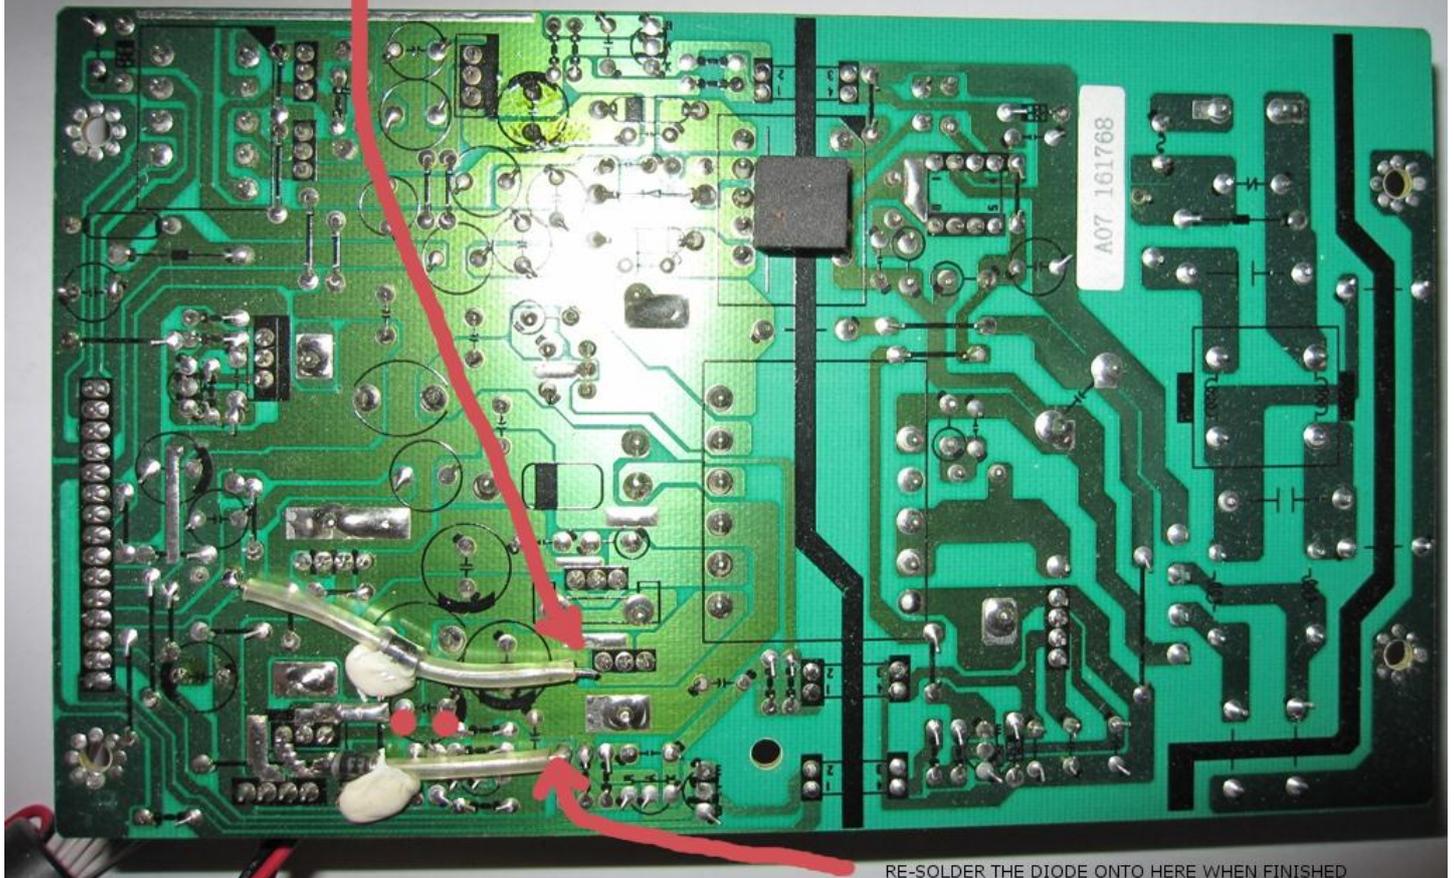
TO MAKE LIFE EASIER WHEN REPLACING ONE OF THE 470uf CAPS...

SIMPLY UNSOLDER THE LEG OF THE TVS DIODE THAT GETS IN THE WAY AND BEND IT UPWARDS AS PICTURED HERE.

BE SURE TO PUT IT BACK THOUGH WHEN FINISHED.

Unsolder and remove the old components one at a time and then use solder braid to clean off any solder left on the PCB solder pad. This will then leave you a nice clean, unblocked hole (2 of them for each component) for which you can then drop in your new component and line it up before soldering it in permanently. Ensure that each component is installed around the right way, as EVERY COMPONENT you are working with is polarised so DO NOT INSTALL THEM AROUND THE WRONG WAY (more notes on this 4 paragraphs down). Once you have soldered each into place, remove the excess wire/leg of the components using wire cutters, they should be cut flush with the solder pad, as per all other joints on the PCB. When unsoldering and soldering in the components, you will notice that one of the capacitors is in between 2 diodes covered in heat tubing. Take a look at PICTURE 5 below for a way to make your life easier when soldering in this capacitor!

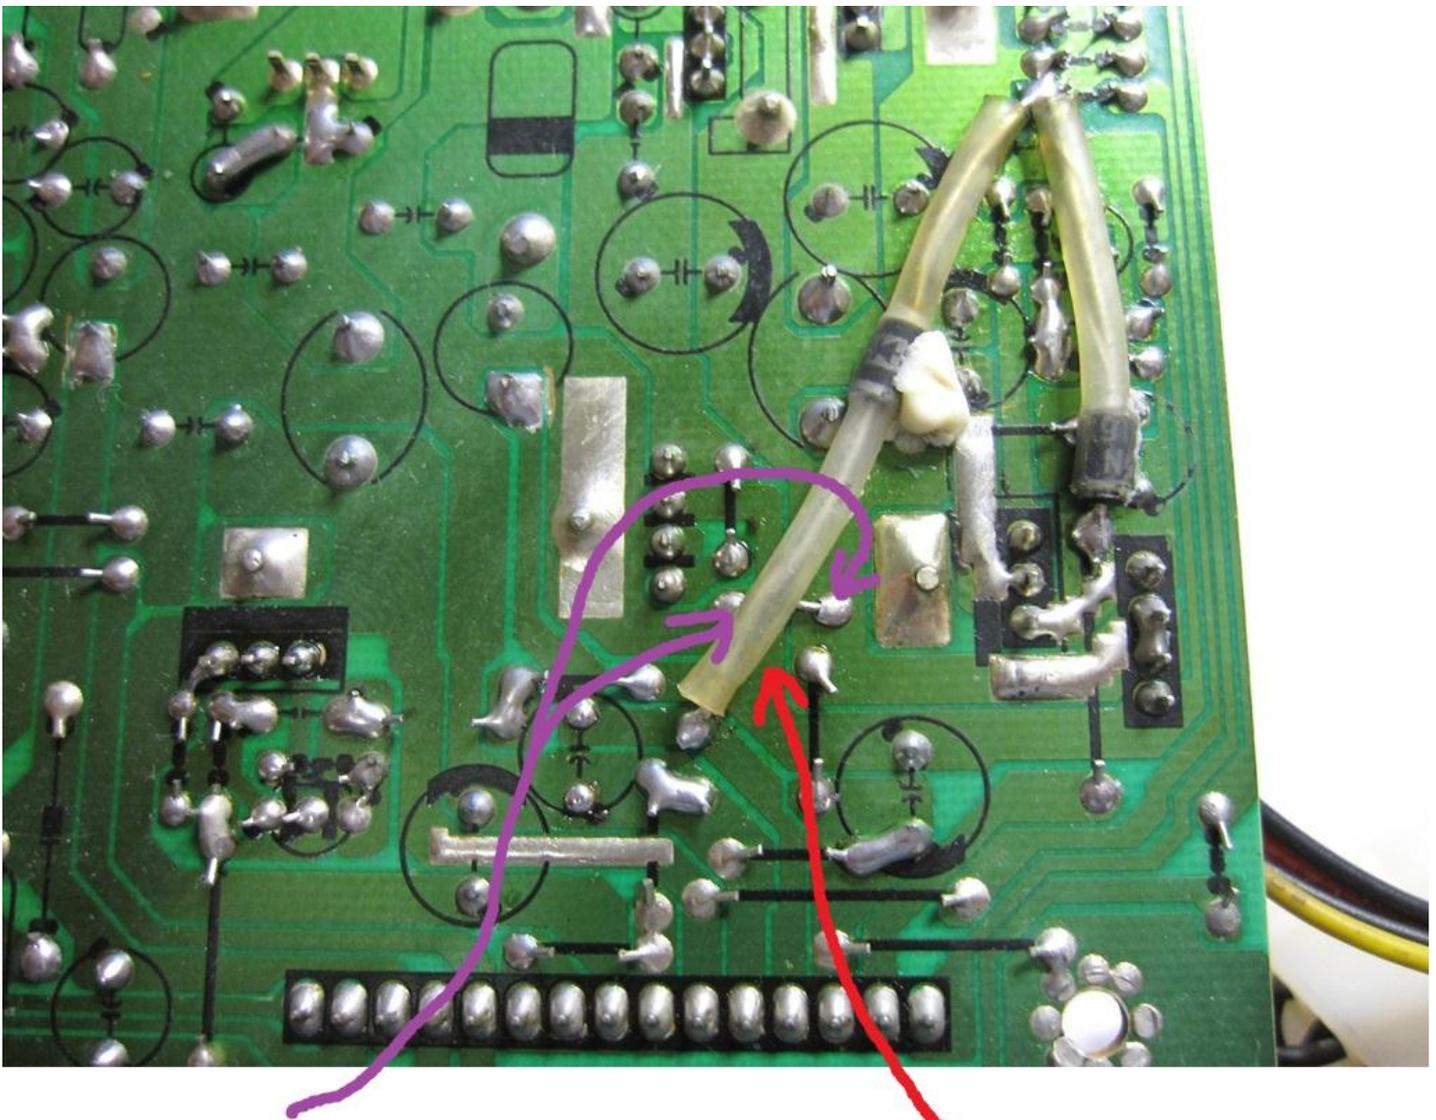
PICTURE 6 is a close up of the diodes and of the 2 joints usually responsible for the diode shorting out. If you look closely, the edge of one of the joints is underneath the diode and the other is just about touching the right side of the diode. Because the 2 legs bend and point inwards towards the diode, it reduces the space between the legs and the diode cannot sit flat on the PCB, and instead usually lies across the joints. Over time heat wins and the leg of the component below penetrates the heat shield of the diode and hey presto, it shorts.

To avoid this unsolder the leg of the diode pointed to by the RED arrow and bend it up. Then using a flat bladed screw driver, bend the 2 legs pointed to by the PURPLE arrows so that they point outwards away from the diode instead of inwards onto the diode. Once bent correctly, resolder the 2 joints to make sure they are ok and then bend the diode back down and resolder it into place as well. This will allow the diode to sit happily between these 2 joints without any chance of it shorting in the future.

COMPONENT JOINTS THAT USUALLY SHORT ON THE DIODE

THE DIODE HEAT COVER

The last thing you need to do in the repair before signing off on it is prevent shorting of one of the diodes underneath the PCB (if not already too late), shown in PICTURE 6 below. Basically the heat protective cover around the 2 diodes degrade over time with heat, and sometimes the diode can short on other component legs that it happens to be lying over the top of. This is bad - very bad. If it has happened you will almost certainly have issues with your mainboard even after repairing the PSU.
